SITE CLASSIFICATION REPORT 325 POI POI STREET BAMAGA QLD 4876

CUSTOMER:	Struxi Design Pty Ltd.	REPORT:	GT23-292-006R REV 1
POSTAL ADDRESS:	Suite 12 Level 1, 203 Margareta Street Toowoomba QLD 4350	DATE:	18 th December 2023
INSPECTION DATE:	28 th November 2023	ORDER No:	NA

A site investigation was undertaken at **325 POI POI STREET BAMAGA** to determine the foundation conditions and classify the site for a proposed three (3) bedroom low-set dwelling.

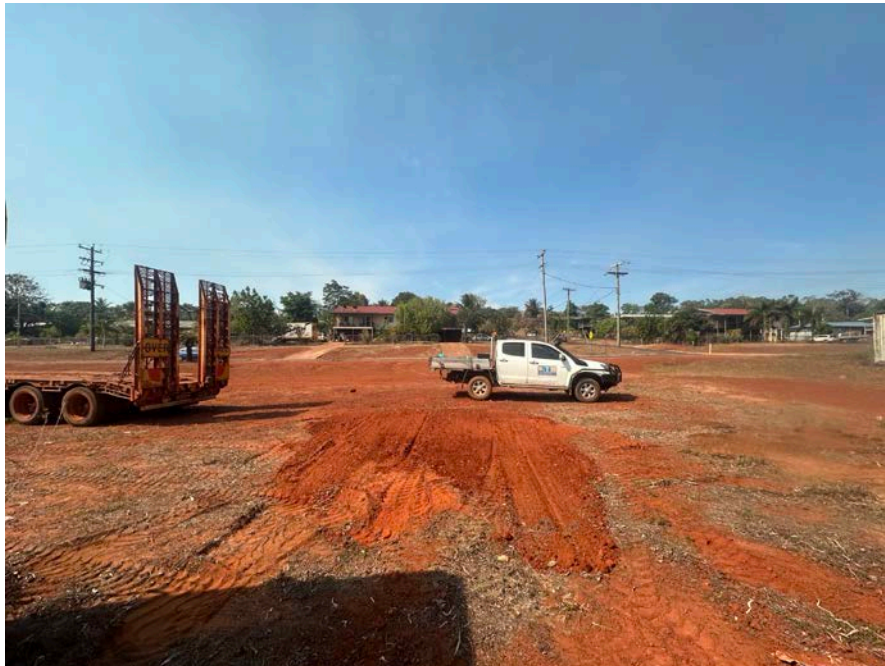
PHOTOGRAPH 1: - View of 325 Poi Poi Street, Bamaga

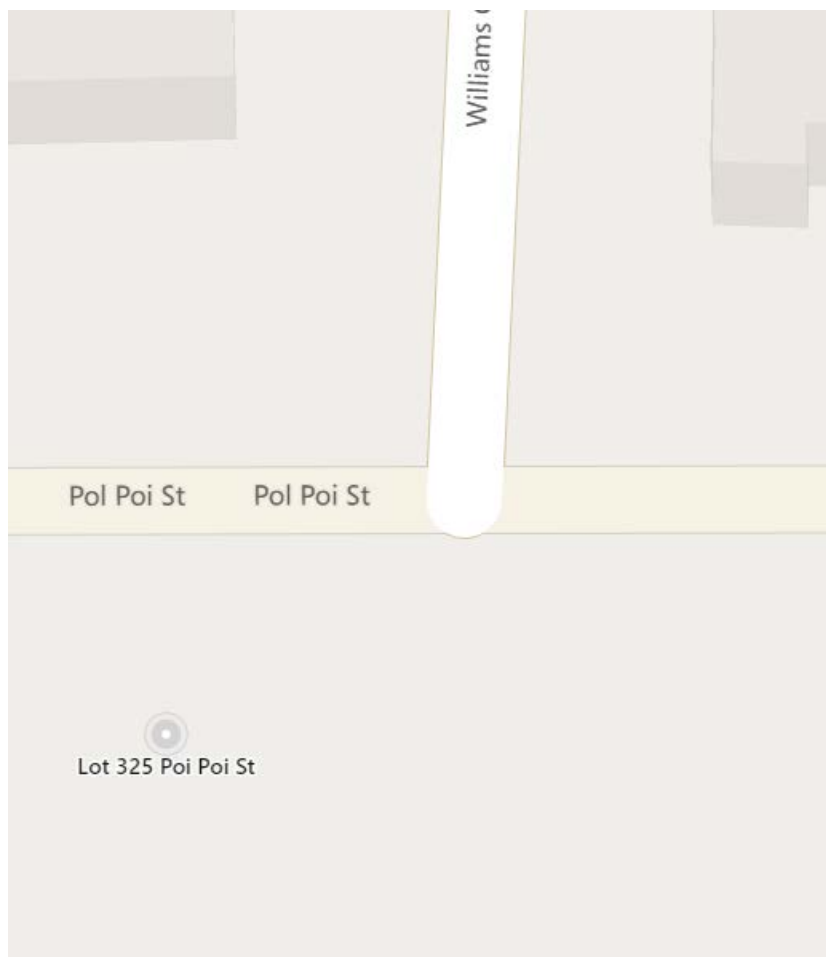
FIGURE 1 – SITE AND TEST LOCATION

Figure 1 present a locality plan of the site that also shows the test location.
